R&J Home Inspections

Property Inspection Report

Street Address, Imdio, CA 92203
Inspection prepared for: Customer
Date of Inspection: 6/9/2018 Time: 9:00 AM
Age of Home: 15 years Size: 2528 sq. ft.
Weather: Sunny

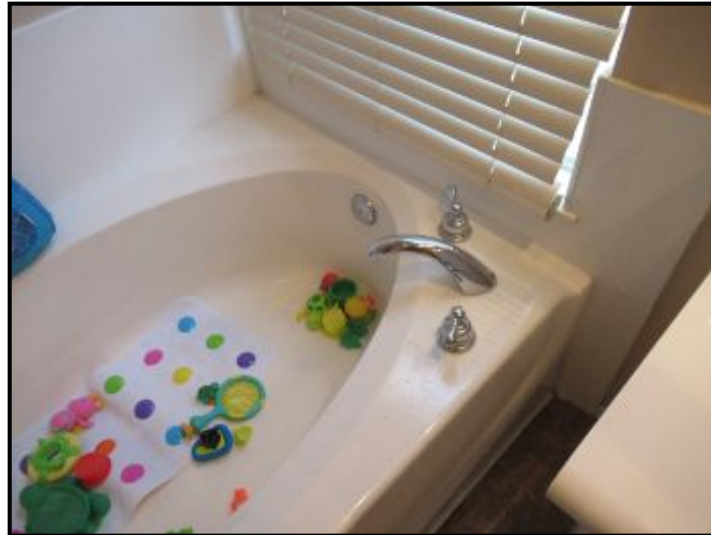
- Leaking tub filler - recommend repair.

Leaky faucet in master bath - recommend repair.

- Tub filler in master bath - slow leak noted - recommend repair.

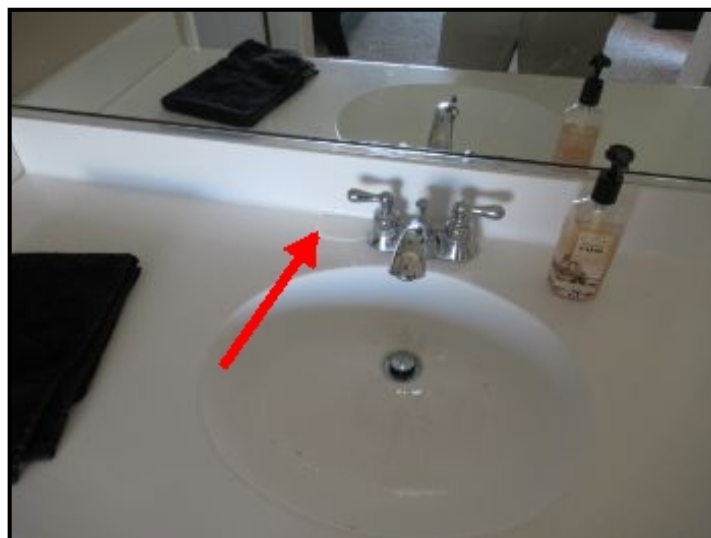
- Faucet in casita leaking on top of sink when valve is turned on - recommend repair.

Water link at faucet in casita - recommend repair.

- No leaks or anomalies noted. EXCEPTION: sink in casita exhibited leak around faucet - recommend repair.

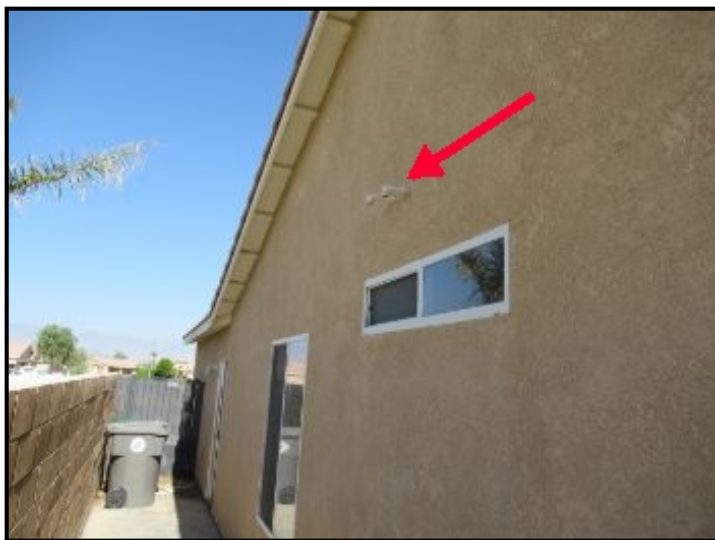
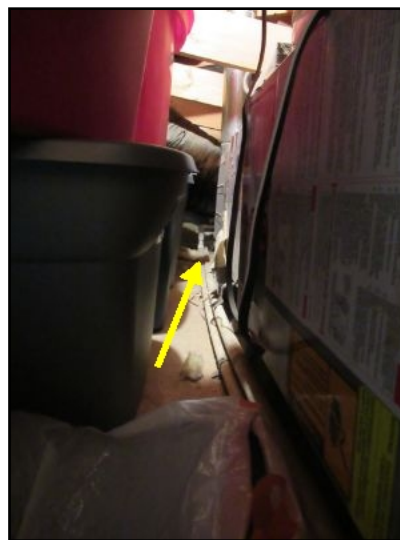
- **A/C** condensate drain line has elbow that points in upward direction in attic, allowing water to collect in drain line - recommend re-routing drain line to drain condensate properly, away from house.

A/C condensate lines - recommend re-positioning away from house Image showing A/C drain line routed upwards, not allowing water to drain properly

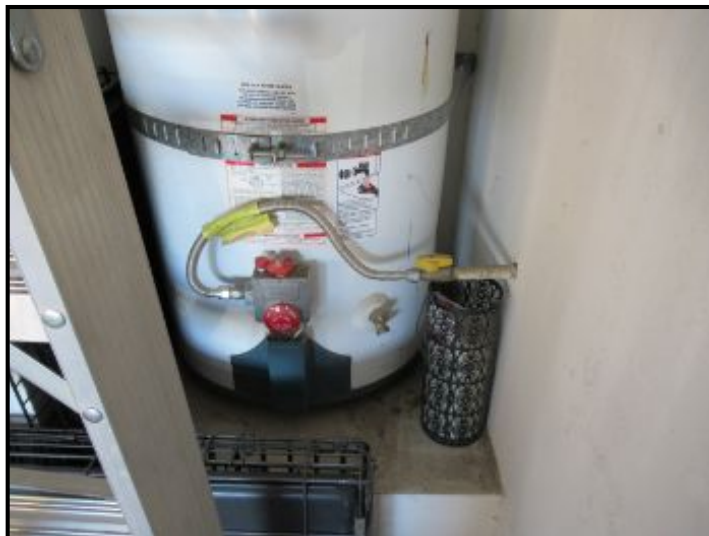
- Water heater pan is missing - recommend adding pan to mitigate water damage if water heater leaks.

Pan is missing - its presence is recommended to mitigate damage if water heater leaks - recommend adding.

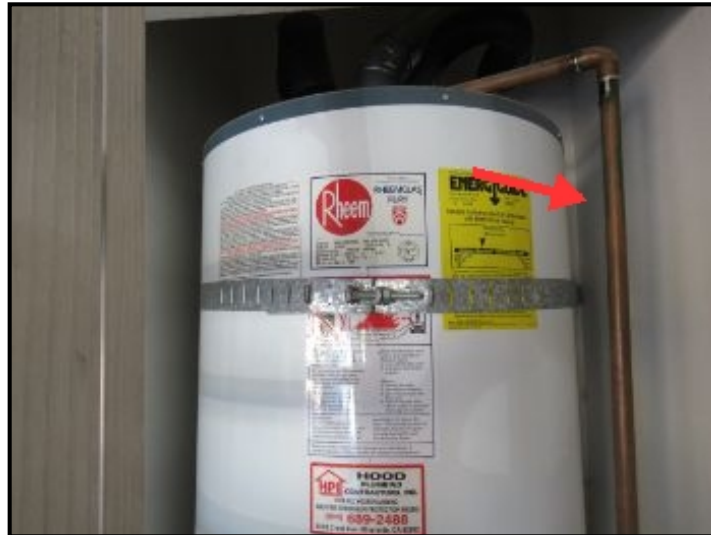
- The discharge tube discharges above six inches from slab, this should be lowered due to the possibility of scalding should a discharge situation happen.
- A Temperature Pressure Relief Valve (**TPR Valve**) present. This safety valve releases water (and thus relieves pressure) if either the temp or pressure in the tank gets too high. The TPR valve discharge tube must be made of copper, iron, or CPVC (NOT regular **PVC**). It must terminate within 6" above the floor--the end cannot be threaded or have a fitting.

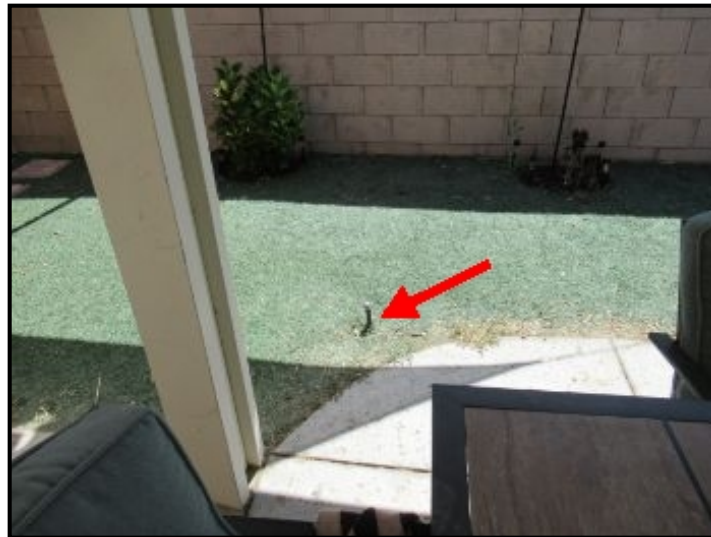
- **Gas stub is above ground near patio - trip hazard - recommend capping below ground level.**

Natural gas stub next to patio - recommend capping below walking surface - trip hazard.

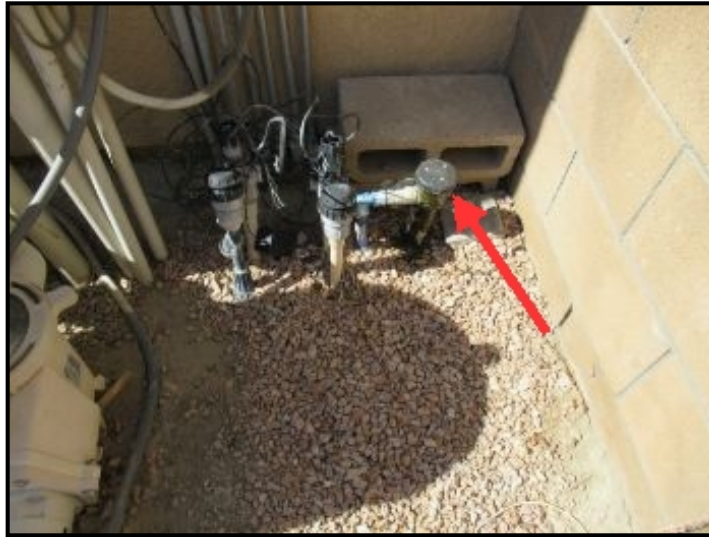
- **Sprinkler control valve leaking - recommend repair.**

Leaking sprinkler valve - recommend repair.

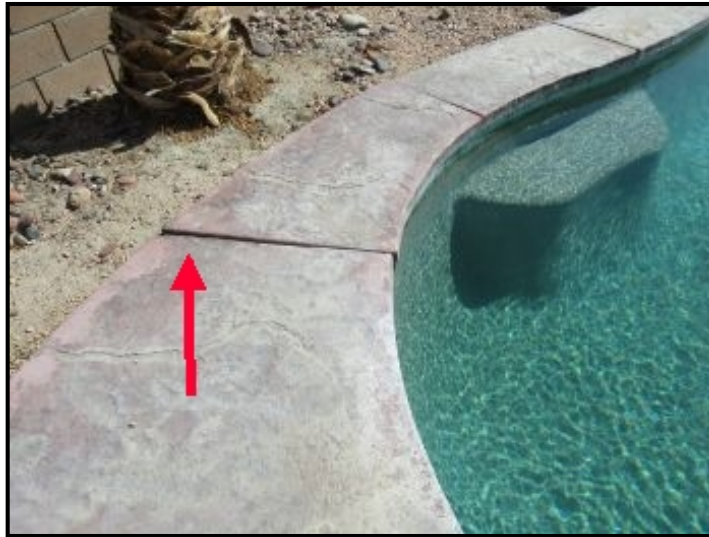
- No major system safety or functional concerns noted at time of inspection.
- **Palm tree stump next to concrete pool deck has raised a section of the concrete resulting in a trip hazard - recommend removing stump and leveling concrete section.**

Section of concrete slightly lifted by old palm tree

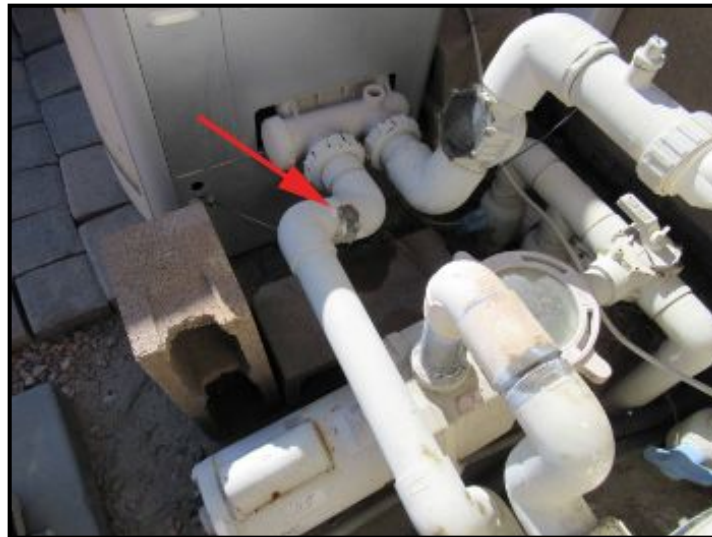
- operated
- **Visible leaking from heater inlet - recommend repair.**

Leak in heater inlet line - recommend repair
